Technical Report

# Door gaps and natural ventilation with adjoining rooms

Date: 03.21.2022

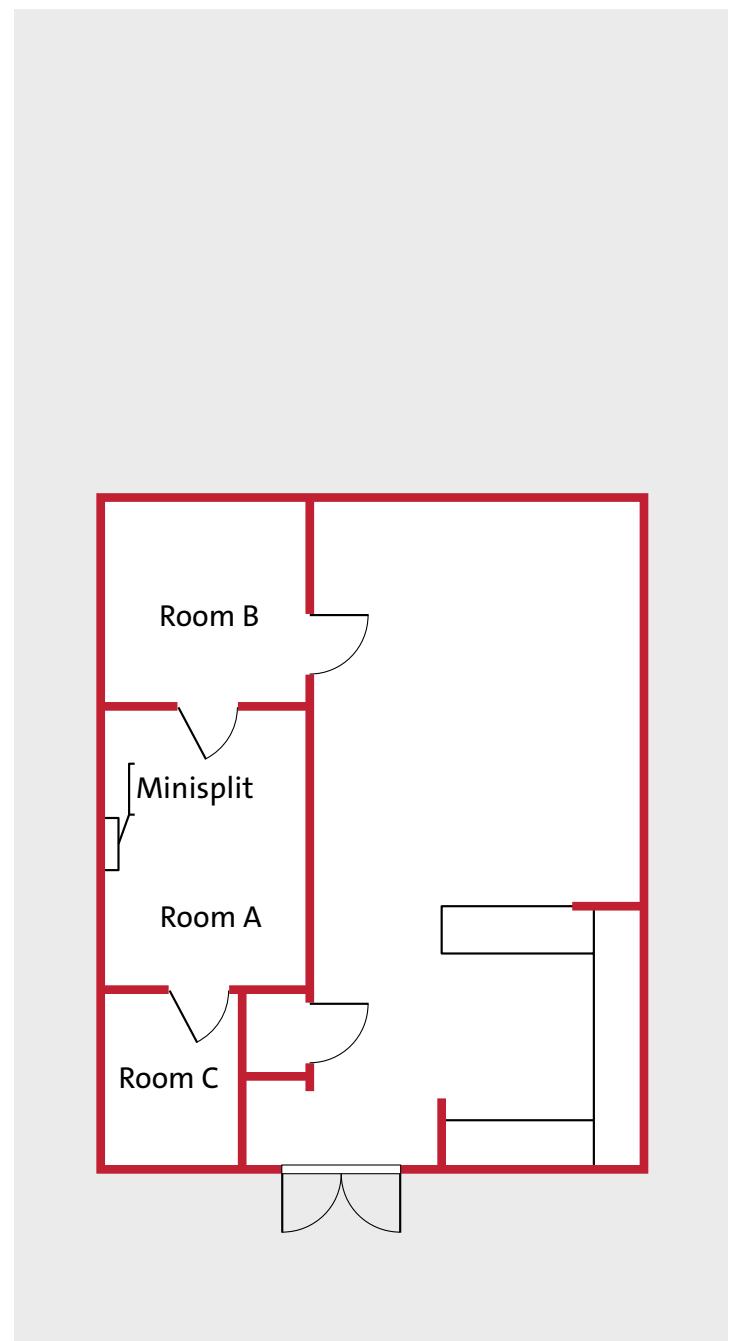
Figure 1 - Room layout

All of the refrigerant releases detailed in this report were conducted using R 32, a single component refrigerant. The refrigerant was introduced into the space by simulating a leak in the coil of a mini split that was located on the wall in Room A, as shown in Figure 1. The minisplit was installed on the wall with the bottom 2.1 m (83.5 in) off the floor. Leak rates were around 2.8 g/sec (5.9 oz/min) which corresponds to the Enhanced Tightness Refrigerating System (ETRS) leak rate of 10 kg/h. For each test the total amount of release was 3.84 kg (8.4 lbs). Sensors, which had been calibrated to determine the volume fraction of refrigerant, were placed at various points in the room where refrigerant was released as well as in the adjoining rooms.

The clearance between the bottom of the door and the floor were adjusted and the concentration profile during and after the release can be compared. Three different arrangements were conducted: a door sealed tight and seams taped; small clearance of 4 mm by 800 mm (0.16 in x 32 in) below the lower edge of the door; and a larger clearance opening of 25 mm by 800 mm (1 in x 32 in).

As a part of this study, rooms were constructed to simulate a  $66.9 \text{ m}^2$  ( $720 \text{ ft}^2$ ) apartment in one of UL's test chambers. The structure was built using standard construction materials and techniques that would be used in North America. The walls were framed using 2x4 inch dimensional lumber and two layers of drywall for durability and strength. A layer of foam sill gasket was placed between the footer and the cement floor of the test chamber. The seams of the drywall were sealed using standard joint compound and the rooms were given two coats of white paint. All interior doors were standard single pre-hung interior doors.

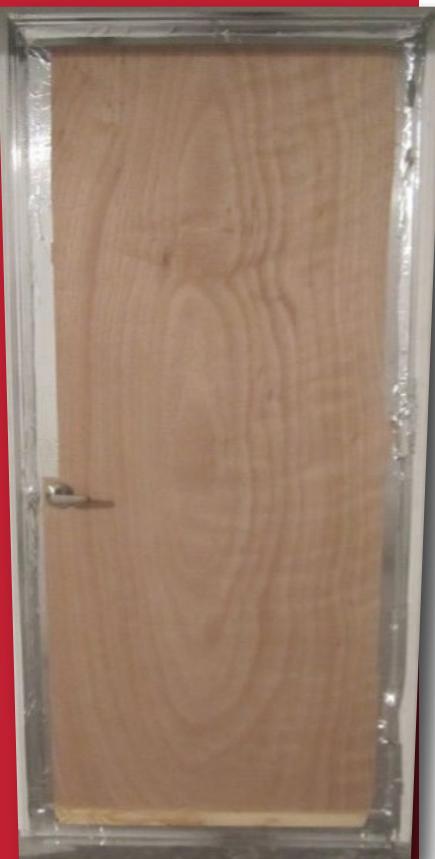
Figure 3 - Door sealing

For this test the doors to the adjacent rooms were sealed around the perimeter using aluminum tape (see Figure 3). Refrigeration sensors were placed in several locations in each room. The refrigerant concentration for sensors located at three corners of Room A are indicated in Figure 2. This shows small differences for horizontal locations when there is a difference between sensor heights. The other figures in this report will only detail concentration at one location. It is expected that any location in the room should have similar concentration.

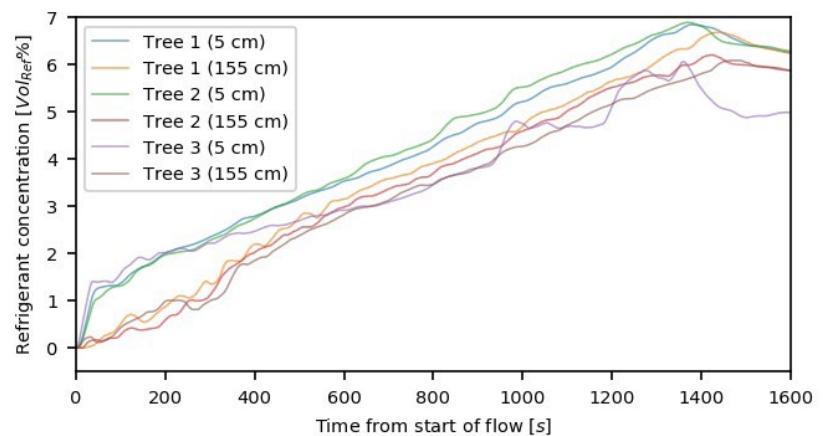
Figure 2 - Refrigerant concentration in Room A

The refrigerant concentrations in the rooms are identified in Figure 2.

From this data we can see that the majority of the refrigerant released stays within the room where it was released. At the start of the release, the refrigerant sensor closest to the floor responds quickest, with the sensors at 80 cm and 155 cm responding to a significant refrigerant rise at 200 s and 600 s, respectively. At the end of the release the refrigerant concentration was approximately 6.5% for all sensors located up to 155 cm (61 in) height. The floor area of the room A is 15 m<sup>2</sup>, so the volume of refrigerant remaining in the room was estimated at  $15 \times 1.55 \times 0.65 = 1.51 \text{ m}^3$  (53.33 ft<sup>3</sup>). This corresponds to 3.2 kg (7 lbs) of refrigerant.

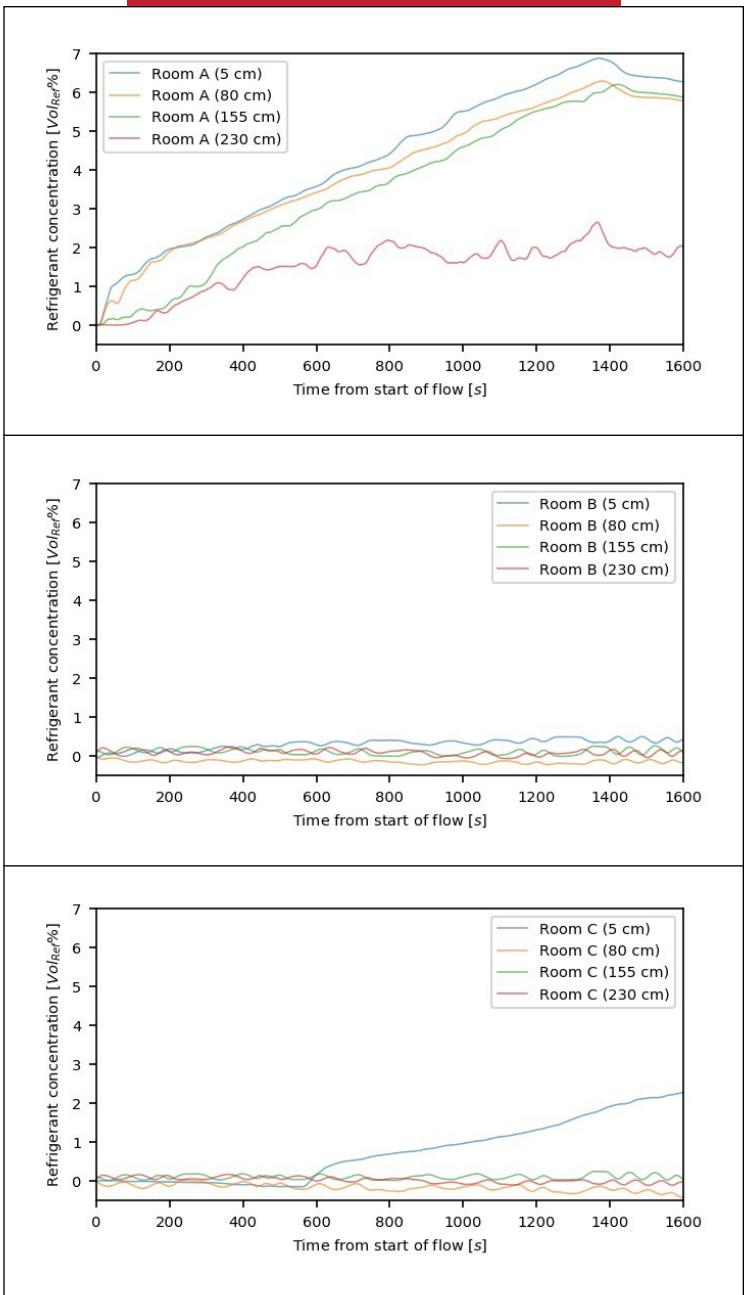
Figure 4 - Room tightness concentrations

There is a concentration rise at the lower sensor in Room C, which starts 600 s after the start of the release. We do not see this same concentration rise in Room B, so there must have been an opening that was not completely sealed.

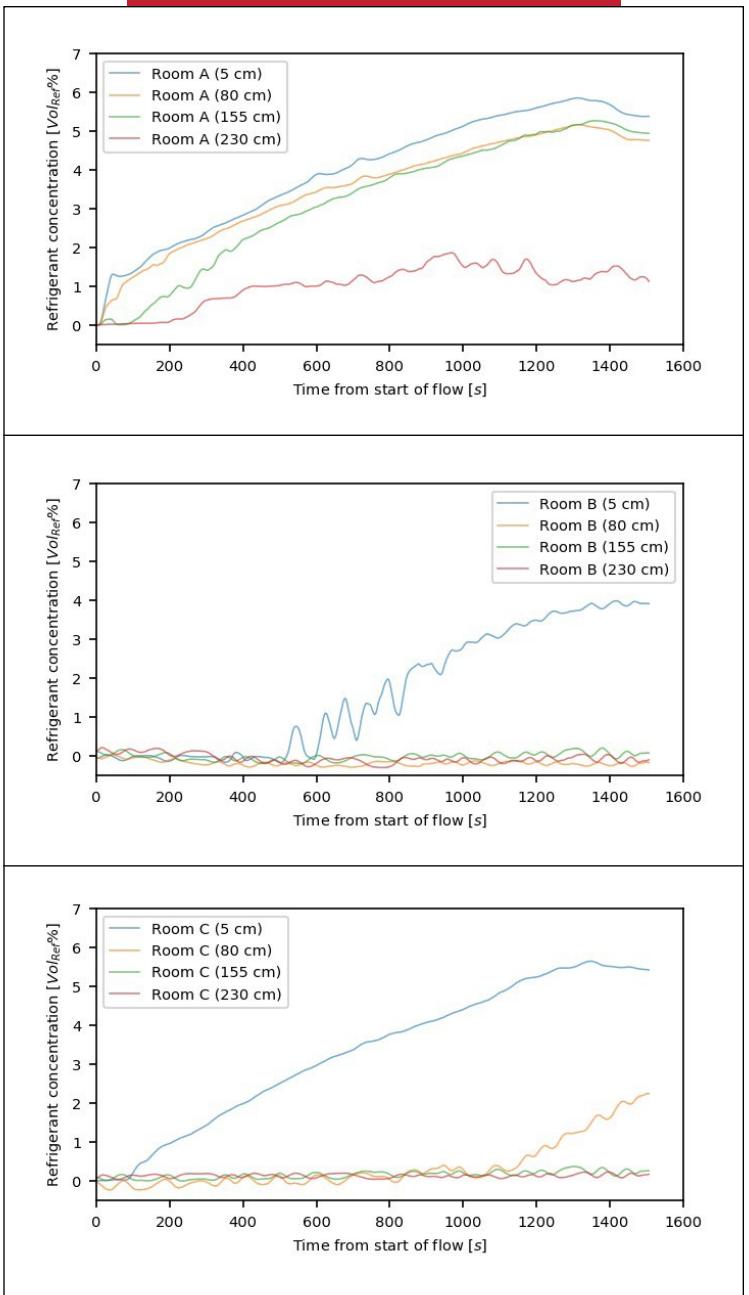
Figure 5 – Small clearance concentrations

A strip of wood was attached to the lower edge of the door allowing for the clearance between the bottom of the door and the floor to be controlled. Prior to this test, the clearance at the bottom of the door was set to 4 mm. We are seeing that the refrigerant concentrations are highest in the room with the refrigerant release. In addition, there is evidence that the refrigerant is flowing under the doors and into the two adjoining rooms.

The sensors located 5 cm above the floor both see a refrigerant rise after the start of the release. The sensor at the floor level (5 cm) in Room C responds faster and shows a higher concentration than the sensor in Room B. Refrigerant is also detected at the 80 cm sensor in Room C. These differences in the response and concentrations are due to two factors: room size and overall structure geometry. Room B has a floor area of approximately 173% of Room C. We can then expect higher concentrations in the smaller room, assuming equal refrigerant ingress rates. Room B is also connected to the larger room space by another door. Any refrigerant introduced to Room B will also progress and mix in the larger room space, which is why there is no refrigerant concentration indicated at the 80 cm height for this room.

The concentration in Room A was approximately 1% lower than the tight room test for sensors at a height of 155 cm (61 in) and lower. The remaining refrigerant in the space is estimated 2.7 kg (5.9 lbs), with 0.5 kg (1.1 lbs) of refrigerant flowing through the 4mm (0.16 in) door gap.

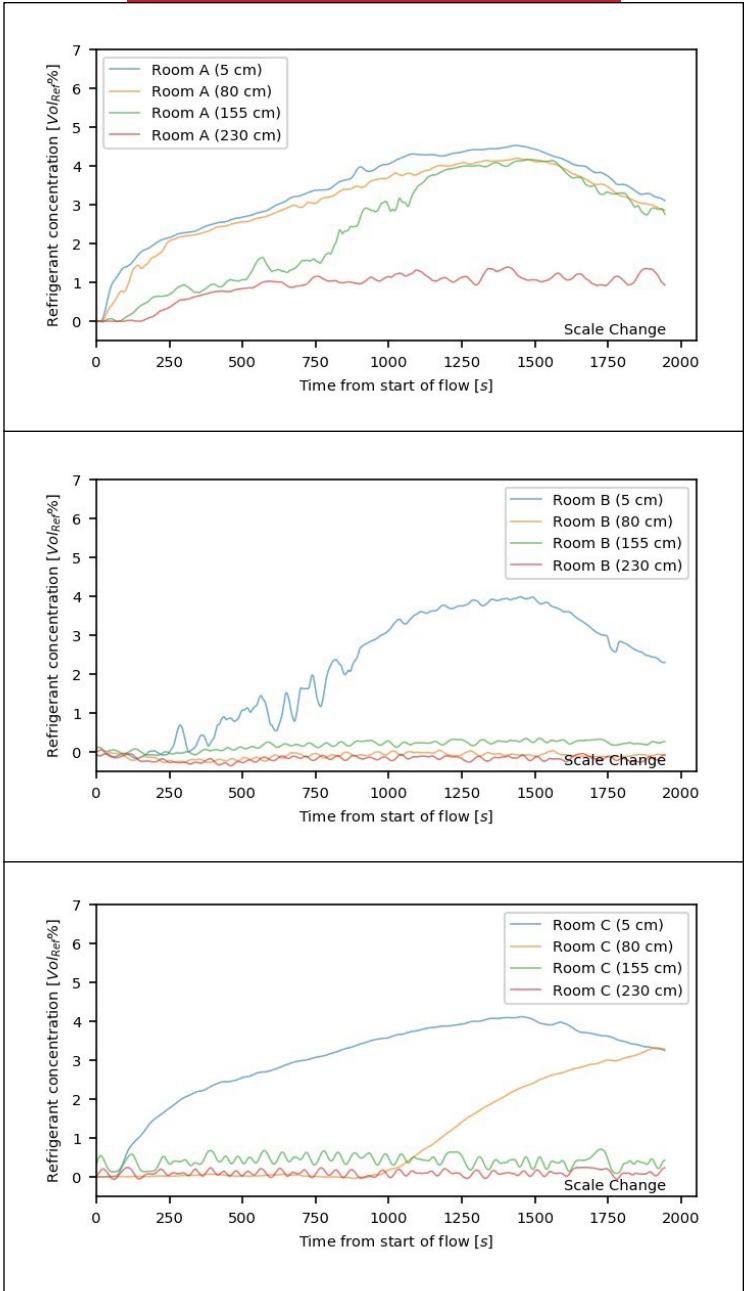
Figure 6 – Larger clearance concentrations

Prior to the refrigerant release in this test, the clearance at the bottom of the interior doors was set to a 25 mm (1 in) clearance. We are seeing that the refrigerant concentrations are highest in the room with the refrigerant release. As with the smaller door clearance, there is evidence that refrigerant is flowing into the two adjoining rooms.

The concentration increases in Room B were similar to the smaller door clearance case but reached faster. The concentration increases in Room C were slightly lower than they were during the small clearance tests. However, the refrigerant is mixing faster within the room volume as the concentration increases was started earlier with these tests. This, along with the lower concentrations in Room A, indicates that the refrigerant mixture near the floor is passing beneath the doors and into the larger room space. The peak concentration of Room C was close to that of Room A. This shows that if a room is connected through an opening of 25 mm x 800 mm (1 in x 32 in), the concentration in the small room behaves similar to that of a larger connected space.

Interior rooms of buildings are not tightly constructed. A small opening—such as a 4 mm (0.16 in) gap at the bottom of the door—has a significant impact on maximum concentration of leaked refrigerant in the space. Gaps are always present at the bottom of an ordinary door to facilitate the easy opening and closing of the door. In addition, rooms having only one door and no other opening are very limited. Most rooms have multiple doors, window(s) and closets or similar connected spaces. As the safety standards cannot verify the arrangement and construction of the rooms that the products are installed in, it is important for the installation codes to clarify if door gap sizes can be used as a method to disperse refrigerant. The opening under the door has a significant effect on the amount of refrigerant flowing out of that room. Figure 6 details individual sensors for the test conditions in the previous sections.

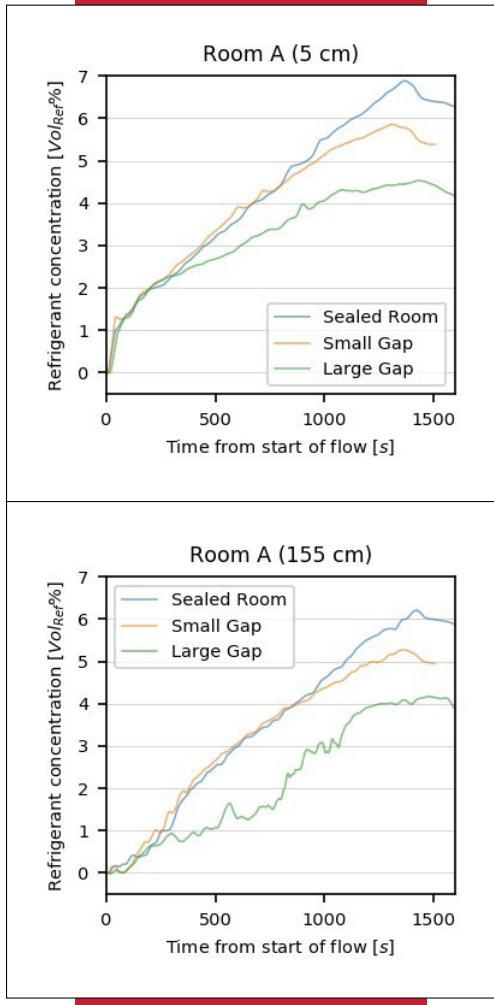
Figure 7 - Door gap summary

There is a 1% absolute refrigerant concentration between the sealed room and small door gap. As the refrigerant concentration increases towards the lower flammability limit (LFL), the pressure differential between the rooms would increase, and the refrigerant velocity into the other rooms would increase. Fluid velocity at a hole is generally proportional to square root of pressure difference, so velocity is almost proportional to square root of the concentration. In addition, refrigerant concentration increases proportionally to the escaping mass of refrigerant. The tests in this study were conducted below half of LFL. If concentration in the room approaches LFL, it is expected that the refrigerant velocity from the room is expected to be increased by a factor of 2.8.
